## Board of Adjustment Case Report

**Case File:** A-127-17

**Property Address:** 2605 Sanderson Drive

**Nature of Case:** A request for a special use permit to authorize the expansion of a nonconforming principal structure pursuant to Section 10.3.6.A.6. of the Unified Development Ordinance to permit an addition to the existing detached house, a portion of which is currently constructed over a stormwater drainage pipe on a .23 acre site zoned Residential-4 and located at 2605 Sanderson Drive.

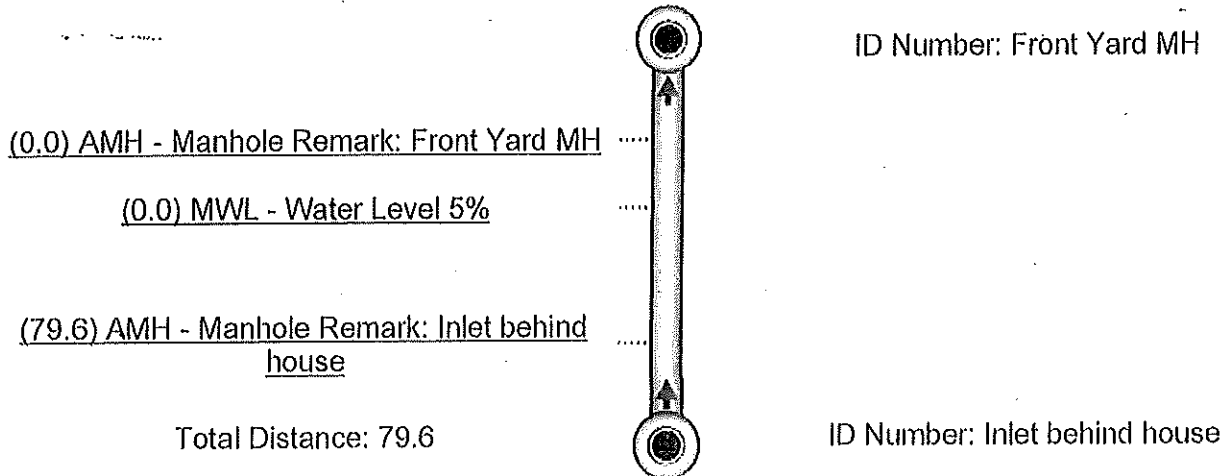
Material: Reinforced Concrete Pipe

Severity
Light
Moderate
Average
Heavy
Severe
